**Cite this article:** Arora H, Kelly M, Worley A, Del Linz P, Fergusson A, Hooper PA, Dear JP. 2014 Compressive strength after blast of sandwich composite materials. *Phil. Trans. R. Soc. A* **372**: 20130212.  
<http://dx.doi.org/10.1098/rsta.2013.0212>

# Compressive strength after blast of sandwich composite materials

Composite sandwich materials have yet to be widely adopted in the construction of naval vessels despite their excellent strength-to-weight ratio and low radar return. One barrier to their wider use is our limited understanding of their performance when subjected to air blast. This paper focuses on this problem and specifically the strength remaining after damage caused during an explosion. Carbon-fibre-reinforced polymer (CFRP) composite skins on a styrene-acrylonitrile (SAN) polymer closed-cell foam core are the primary composite system evaluated. Glass-fibre-reinforced polymer (GFRP) composite skins were also included for comparison in a comparable sandwich configuration. Full-scale blast experiments were conducted, where  $1.6 \times 1.3$  m sized panels were subjected to blast of a Hopkinson–Cranz scaled distance of  $3.02 \text{ m kg}^{-1/3}$ , 100 kg TNT eq

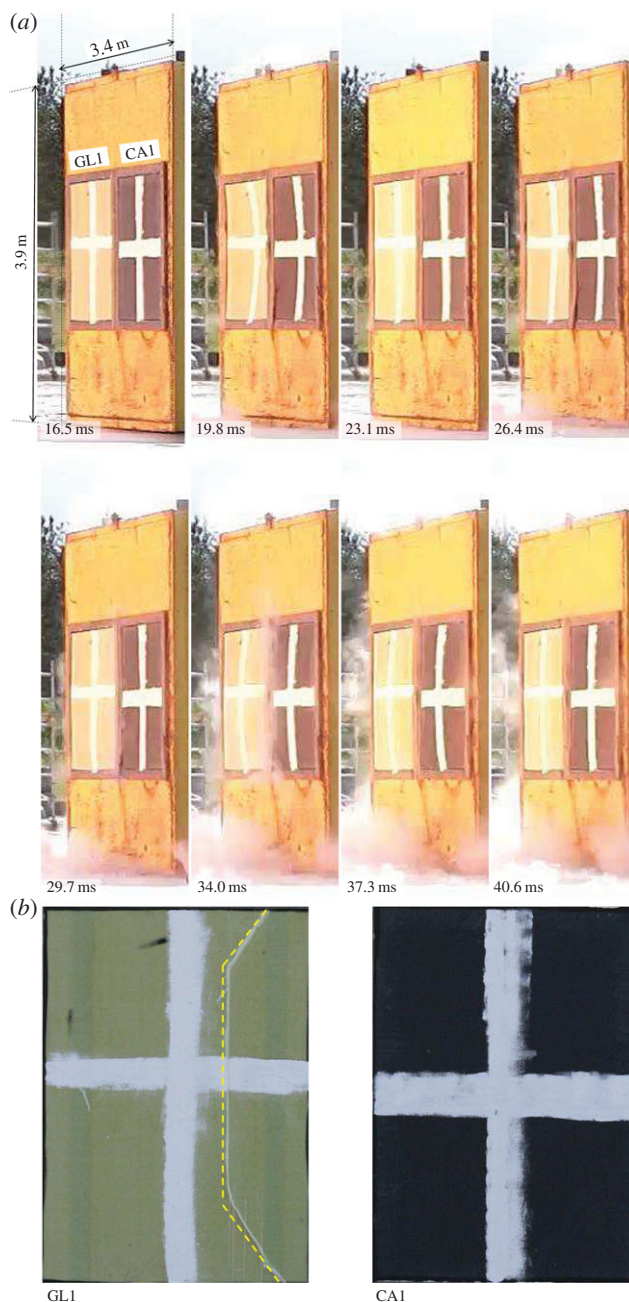
**Figure 3.** (a) Images taken at regular intervals with the shockwave impinging on test samples GL1 and CA1 after 16.5 ms. (b) Final visible front-face damage. Time stamps are relative to detonation time at 0.0 ms. (online version in colour.)

Figures 3 and 4 show sample front-view images taken from the high-speed video cameras positioned on the test pad during the 100 kg nitromethane charge explosion. The shockwave is seen to arrive at the target after 16.5 ms post-detonation. This blast experiment was designed to take the panels beyond their elastic limit and inflict a significant proportion of damage on each target. The test samples have an arbitrary cross painted on their front face for ease of tracking the front face deformation.

Figure 3 shows the effect of the blast on test samples GL1 and CA1. Front-face damage is seen to initiate in the top right corner of GL1 at 19.8 ms and propagate down the right-hand edge. The final front-face damage is shown at the bottom of figure 3, highlighting the relative visible damage sustained by each target. There was no visible skin damage in CA1.

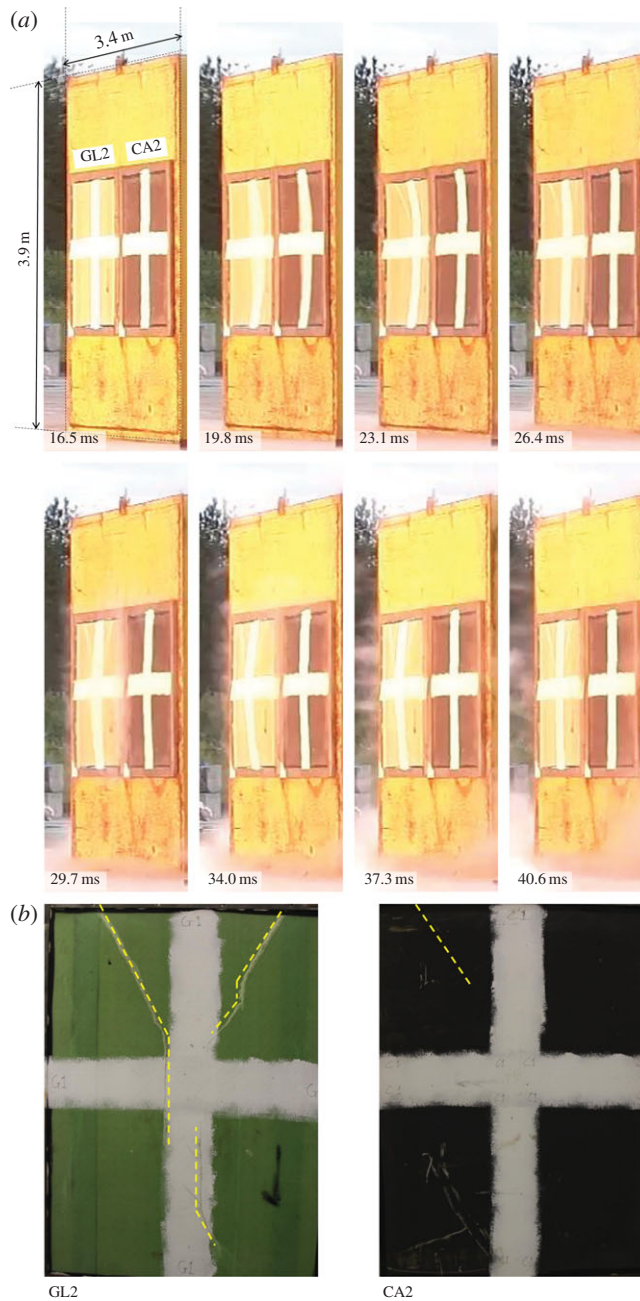
**Figure 4.** (a) Images taken at regular intervals with the shockwave impinging on test samples GL2 and CA2 after 16.5 ms. (b) Final visible front-face damage of targets  $1.6 \times 1.3$  m area. (Online version in colour.)

For the second pair of samples subjected to blast, figure 4 shows the external view of samples GL2 and CA2 for the duration of the loading cycle. Front-face damage is seen to initiate in the top left and right corners of GL2 between 19.8 and 23.1 ms. These cracks propagate down the sides of GL2. This time, in the CFRP panel, there is a small amount of skin failure visible, highlighted in the final front-face damage image at the bottom of figure 4.

as shown previously in figure 4. The damage to the panel also led to a reduced stiffness, which caused an increase in the time for the return response. This was seen in the carbon-fibre panel as an elongated return from maximum displacement in figure 5 and the relatively flat-looking contour plot in figure 8. It took 1 ms longer for the carbon-fibre panel to return to its original position than the glass-fibre panel owing to the difference in core crack distribution observed in the carbon-fibre-skinned panels compared with the glass-fibre-skinned panels and other effects.

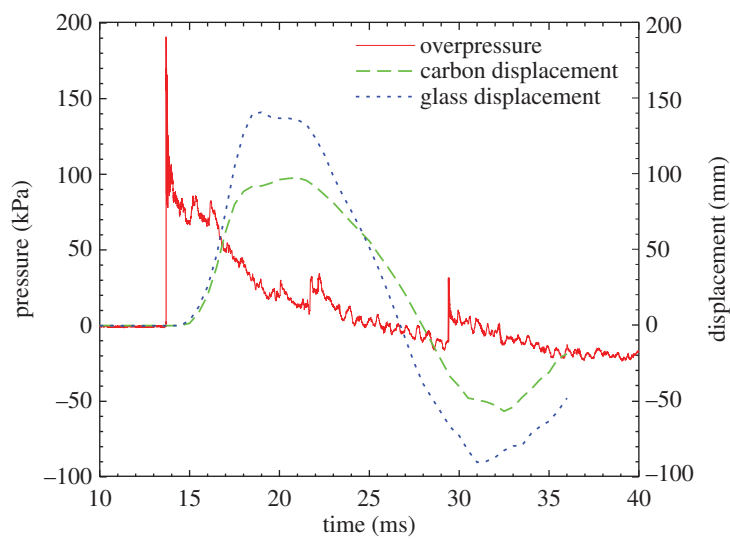
**Figure 5.** Graph showing the out-of-plane displacement of both CA1 and GL1 alongside the synchronized overpressure measurement. (Online version in colour.)

At the 14 m stand-off from the 100 kg charge, an impulse of 420 kPa ms was recorded, and the initial positive pressure wave lasted for 12.0 ms. This is shown alongside the transient central out-of-plane displacement plots for CA1 and GL1 in figure 5.

The glass-fibre-skinned panel, GL1, deformed symmetrically until the point of maximum *z*-displacement. By this point, front-face and core damage had already occurred and affected the return response of the panel, causing a non-uniform rebound response at 20 ms about the peak out-of-plane displacement (see graphic in figure 5). This asymmetry caused by the damaged core is highlighted in the out-of-plane displacement contour plots in figure 6.

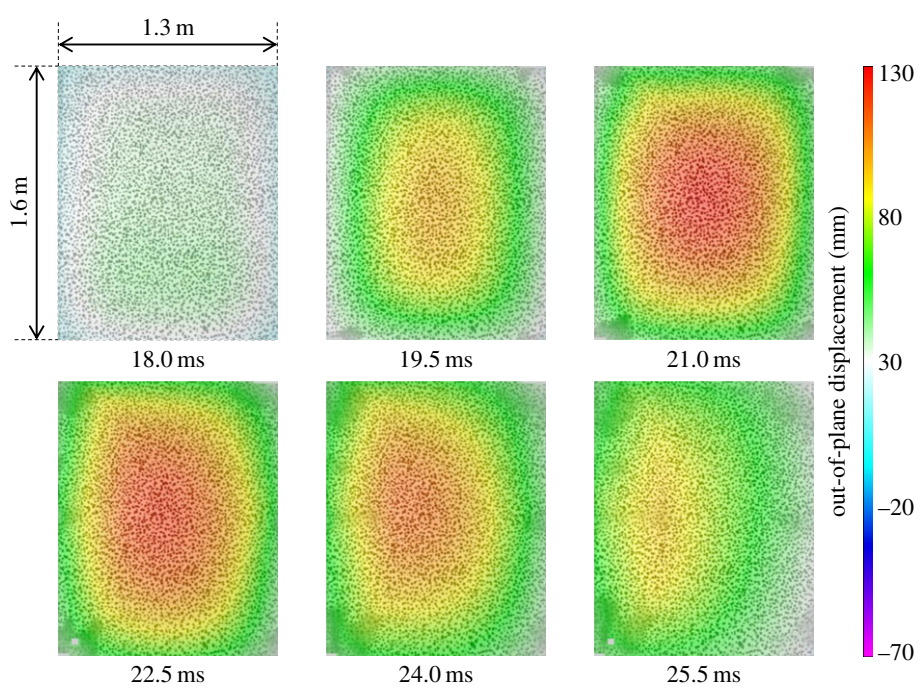
**Figure 6.** DIC analysis of blast on GL1 featuring contour plots of out-of-plane displacement. (Online version in colour.)

see the greatest initial loading. This is evident from the  $U_z$  plots during each blast for the targets in figures 6 and 8. However, composite structures exhibit compliance; therefore the pressures do not build up necessarily to their theoretical maxima based on geometry alone. GL1 was seen to suffer the most damage at the bottom corner closest to the centre of the fixture (4R), whereas CA1 was seen to suffer most damage in the opposite corner (1R). When the blast wave hits the targets, there are a series of transmitted waves and reflected waves. The transmitted waves are either through-thickness surface waves or a combination of shear waves. Upon impact, the bottom-most central corner (GL1-4R and CA1-4L) will be loaded first and see the initial peak loading

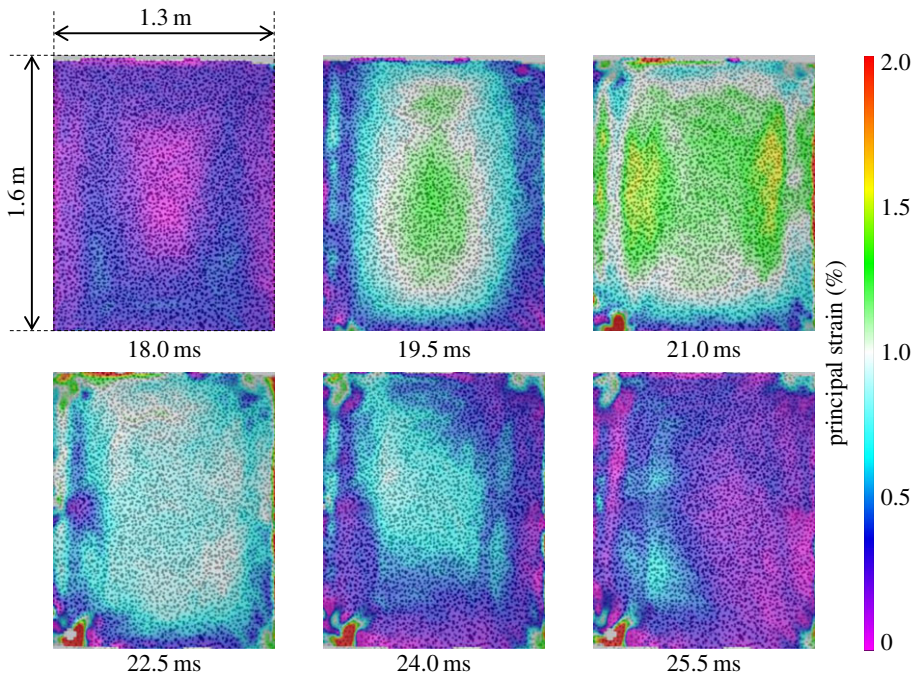
**Figure 7.** DIC analysis of blast on GL1 featuring contour plots of maximum principal strain. (Online version in colour.)

The maximum  $z$ -displacement,  $U_z^{\max}$ , was 140 mm and the maximum principal strain,  $\varepsilon^{\max}$ , peaked at 1.6% towards the right- and left-hand edges of the panel (figure 7). The carbon-fibre-skinned panel, CA1, deflected to a  $U_z^{\max}$  of only 107 mm, owing to a higher stiffness than that of the glass-fibre-skinned panel. Core shear failure was still observed. There was no skin damage visible in CA1, although a fine crack on one of the panel edges of CA2 was observed to occur,

CA1 was seen to have strain concentrating around the edges of the panel in figure 9, with the central region relatively unstrained, complementing the displacement observations in figure 8. Similarly, the edges of the GL1 were relatively highly strained between 18.0 and 21.0 ms; however, this strain progressed to concentrate around a region that suffered complete failure along an edge (figure 7). This coincided with the time at which a front-face failure was observed in figure 3.

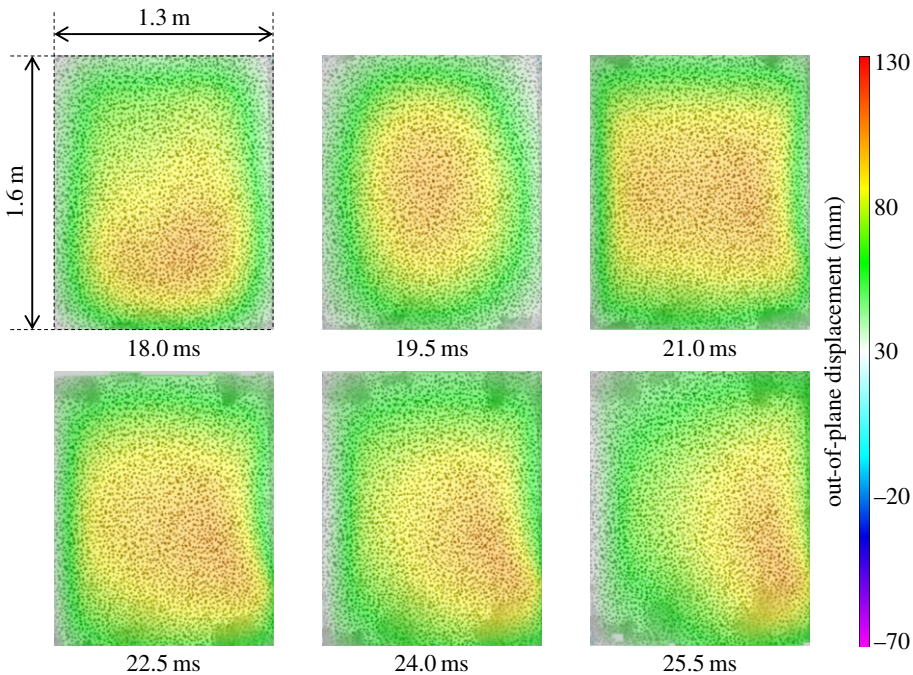
**Figure 8.** DIC analysis of blast on CA1 featuring contour plots of out-of-plane displacement. (Online version in colour.)

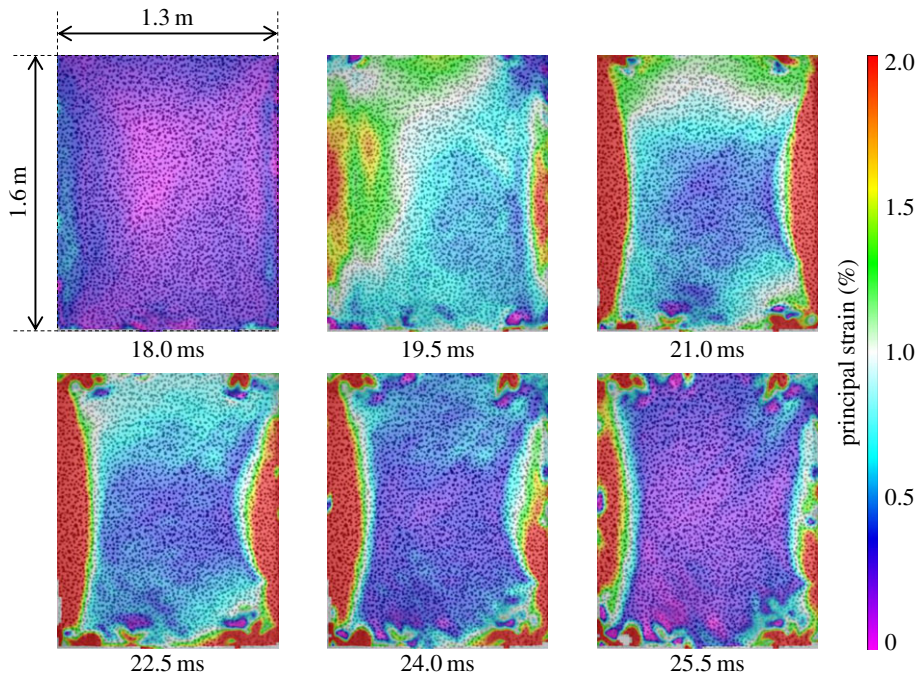
**Figure 9.** DIC analysis of blast on CA1 featuring contour plots of maximum principal strain. (Online version in colour.)

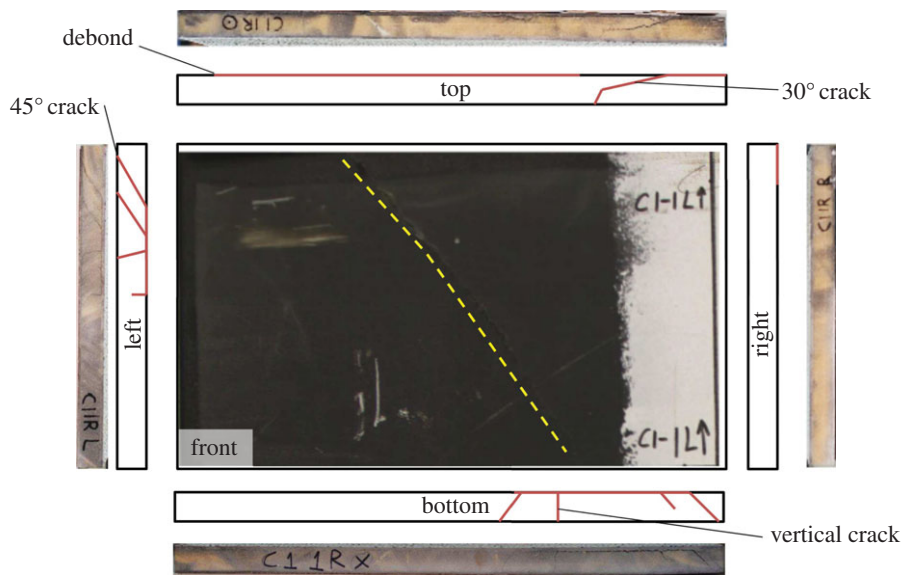
**Figure 11.** An example of the documentation process for visual inspection post-blast on CA1 subpanel 1R (650 × 400 mm in area), showing images and schematics of damage noted. Subpanel 1R is top right when viewed from the rear. (Online version in colour.)

After the blast experiments, the samples were recovered and sectioned into eight equally sized subpanels, 635 × 400 mm in area. The global panels of CA1, CA2, GL1 and GL2 were cut down their vertical into halves and then cut into a further four sections down each side. Each subpanel was then visually inspected for damage. An example of a 1R subpanel (top right when viewed from rear) for CFRP is presented in figure 11 and a 1R subpanel for GFRP is presented in

**Table 2.** Index of damage observed on the subpanel samples shown in figures 11 and 12.

vertically, and then into four smaller panels horizontally. Damage was observed along the edges of each panel, and recorded in a series of images. Examples of such images are shown in figures 11 and 12. These images were used to estimate the degree of damage within each panel to correlate such measures of damage, as presented previously in table 2, with residual strength.

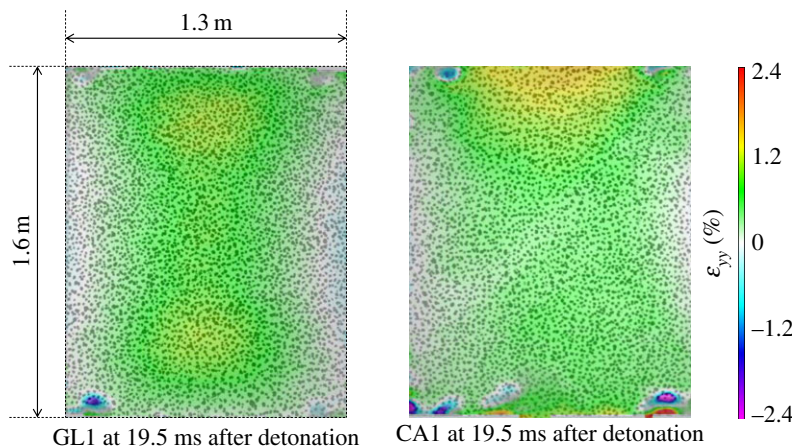
**Figure 13.** DIC analysis showing strain in the y-direction in GL1 and CA1 recorded during the blast taken at 19.5 ms after detonation. (Online version in colour.)

Signs of where the most damaged areas of each global panel occur were available in the DIC analysis. Figure 13 shows the strain in the  $y$ -direction in the image, denoted  $\varepsilon_{yy}$ , for GL1 and CA1. It is shown that the propensity for horizontal cracking along the shorter length ( $x$ -direction) is fairly uniform in GL1, whereas in CA1,  $\varepsilon_{yy}$  is much higher towards the top edge of the target. This goes some way to highlight why visual inspections show that the GFRP panels were more uniformly damaged throughout the target compared with the CFRP sandwich panels. Evidence

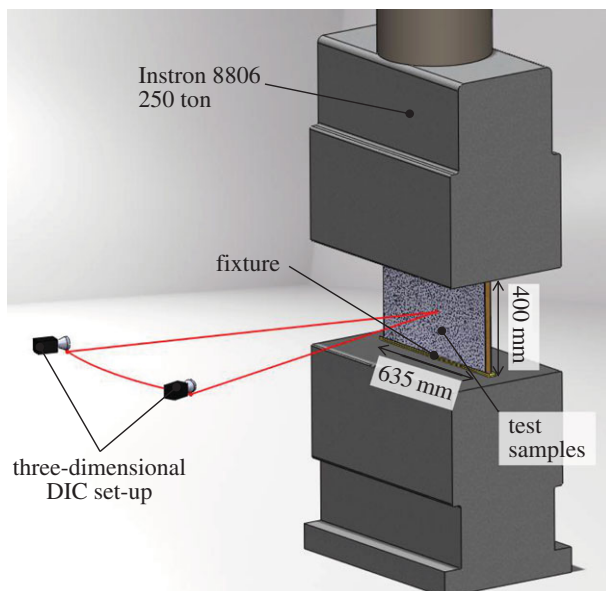
**Figure 14.** Schematic of the experimental test set-up for edgewise compression of sandwich materials. (Online version in colour.)

Two 5 MP digital cameras were set up and calibrated for three-dimensional DIC on one side of the panel, which now had a finer speckle pattern applied owing to the higher resolution of the recording apparatus and the smaller size of the samples, as per standard image correlation practices [33]. In all cases, the imaged face was the skin, which was originally facing the explosive charge. A schematic of the experimental test set-up is shown in figure 14.

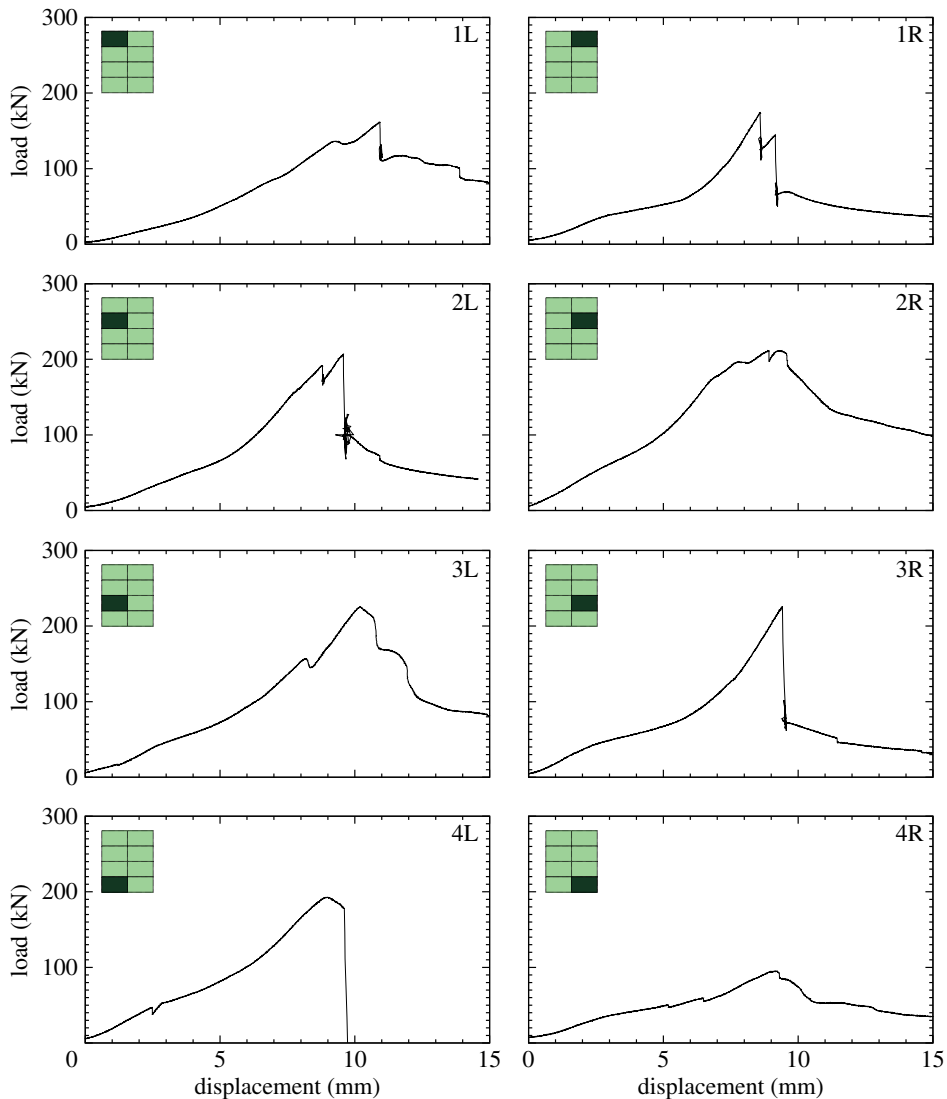
**Figure 15.** Force–time data for each sample in GL1. Data for each subpanel are shown in the position of where it lay in the global blast panel as viewed from rear of panel. The inset shows the location of the subpanel within the GFRP panel. (Online version in colour.)

Figure 15 shows a summary of all the load–displacement plots taken for each subpanel of GL1 tested, with each location of the subpanel within the global blasted panel labelled. It was observed in the glass specimens that the ultimate compressive load was greater for those panels which were situated in positions 2 and 3. The damage here was observed to be less severe than the bottom of the panels. The damage in the centre panels was also noted to be predominantly at the top and bottom, and the DIC data from the blast test (figures 16 and 17) suggested that core cracks travelled vertically, in line with the direction of the compressive load. It can be seen in figure 18 that higher ultimate loads were withstood by the panels in positions 2 and 3, and that, particularly in position 4R, a much lower load was attained before ultimate failure. These panels demonstrated

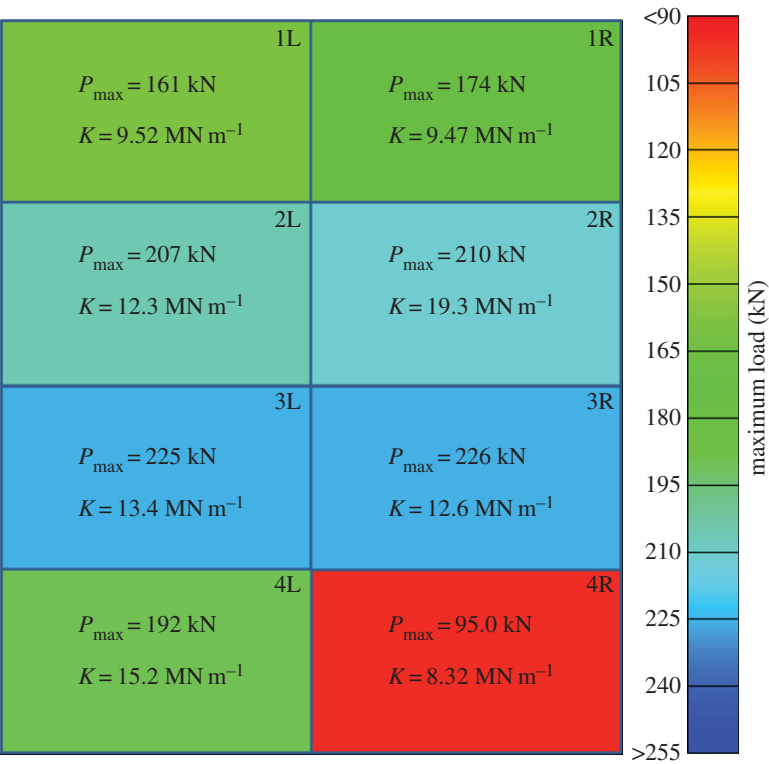
**Figure 18.** Graphic showing, as a greyscale (colour) plot, how ultimate load-bearing capacity varied with location of subpanel on the global GFRP blast panel as viewed from rear. (Online version in colour.)

relative to the whole target, which is also being loaded by the blast. There is a period of build-up during the loading phase, particularly on a non-infinitely rigid surface. The surface waves travelling along the panel are transmitted along the lengths towards other regions of the target, i.e. opposite corners. The faster wave speed in the CFRP targets allows the waves to propagate to the other boundaries quicker than in the GFRP targets. Therefore, damage builds up greatly in the CFRP targets away from the centre. However, in the GFRP targets, the magnitude of the blast wave is sufficient to breach the failure strain of the fibres (especially once support from the core is lost due to shear failures), and so energy dissipation to remote areas from peak-loaded ones is minimized. Energy is lost due to other failure mechanisms in the GFRP sandwich panels such as gross skin failure, rather than simply core damage. Therefore, the more significantly damaged area is focused in the GFRP targets to where the most force is expected to be applied and not necessarily focused in the CFRP targets. This concept is shown in figures 18 and 22.

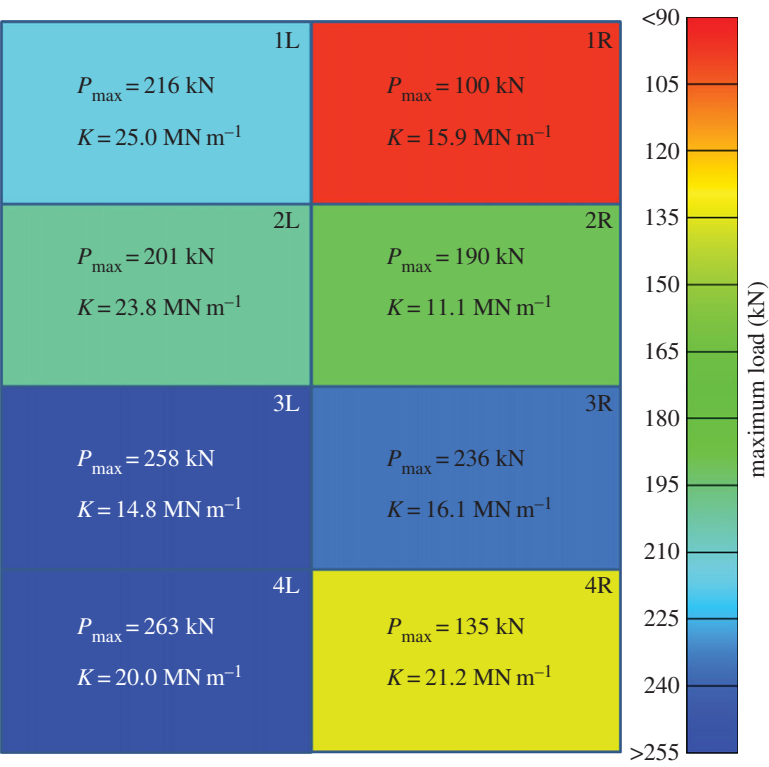
**Figure 22.** Graphic showing, as a greyscale (colour) plot, how ultimate load-bearing capacity varied with location of subpanel on the global GFRP blast panel as viewed from rear. (Online version in colour.)

Ultimate load-bearing capacity data are presented for the CFRP panels in figure 22. It can be seen again that the residual strength of the panels corresponds to the damage severity and orientation observed from the edges of the panels and interpreted from the DIC blast data. In this case, it can be noted that panel 4L demonstrates a very high ultimate compressive strength, and that the corresponding corner, 1R, demonstrates a very low compressive strength. This

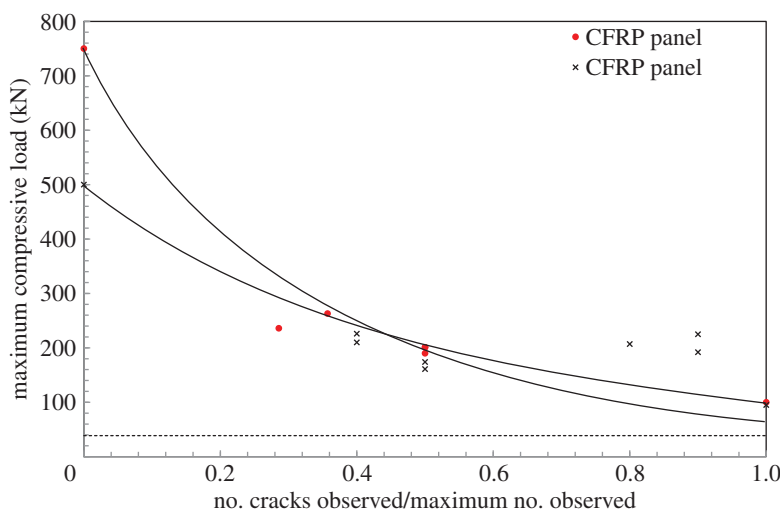
**Figure 23.** Plot showing compressive load against normalized number of cracks recorded prior to compression testing. Dashed line represents the theoretical minimum compressive load to crush the core and buckle the skins. (Online version in colour.)

A number of trends and hypotheses can be drawn from the raw data. However, the importance of core cracking, particularly those normal to the loading direction, can lead to significant reduction in stiffness and load-bearing capacity. The graph shown in figure 23 plots the normalized number of cracks, i.e. the total number of cracks observed visually from each edge of the subpanel divided by the greatest number observed, all plotted against the peak compressive load. The peak values of compressive load were obtained from testing non-blasted materials.

Referring to figure 23, it is seen that the CFRP targets have a much higher initial maximum load-bearing capacity (which is taken to be the buckling load) than the GFRP targets. However, based on the stiffer fibres in CFRP and the improved blast resistance, resulting in greater degree of blast energy absorption, the relative reduction in load-bearing capacity was greater for the CFRP targets compared with the GFRP targets. Furthermore, a stiffer material experiences a higher load (or resistance to impact); therefore the apparent damage induced in the core and interfaces is understandable compared with a more compliant material such as GFRP.

Both targets seem to reach a similar lower level of strength once some small amount of damage is incurred. The graph, however, goes beyond the  $x$ -axis plotted, i.e. the panels can damage further than shown in this paper, to a theoretical maximum damage where the panels are loaded purely to compress the foam core and buckle the skins. This minimum compressive load is shown as the dotted asymptote at the bottom of the graph in figure 23.
